THE GREAT ALASKA EARTHQUAKE

Volume II

Illustrations and Maps

TECHNICAL REPORT NO. AFWL-TR-65-92, Vol II

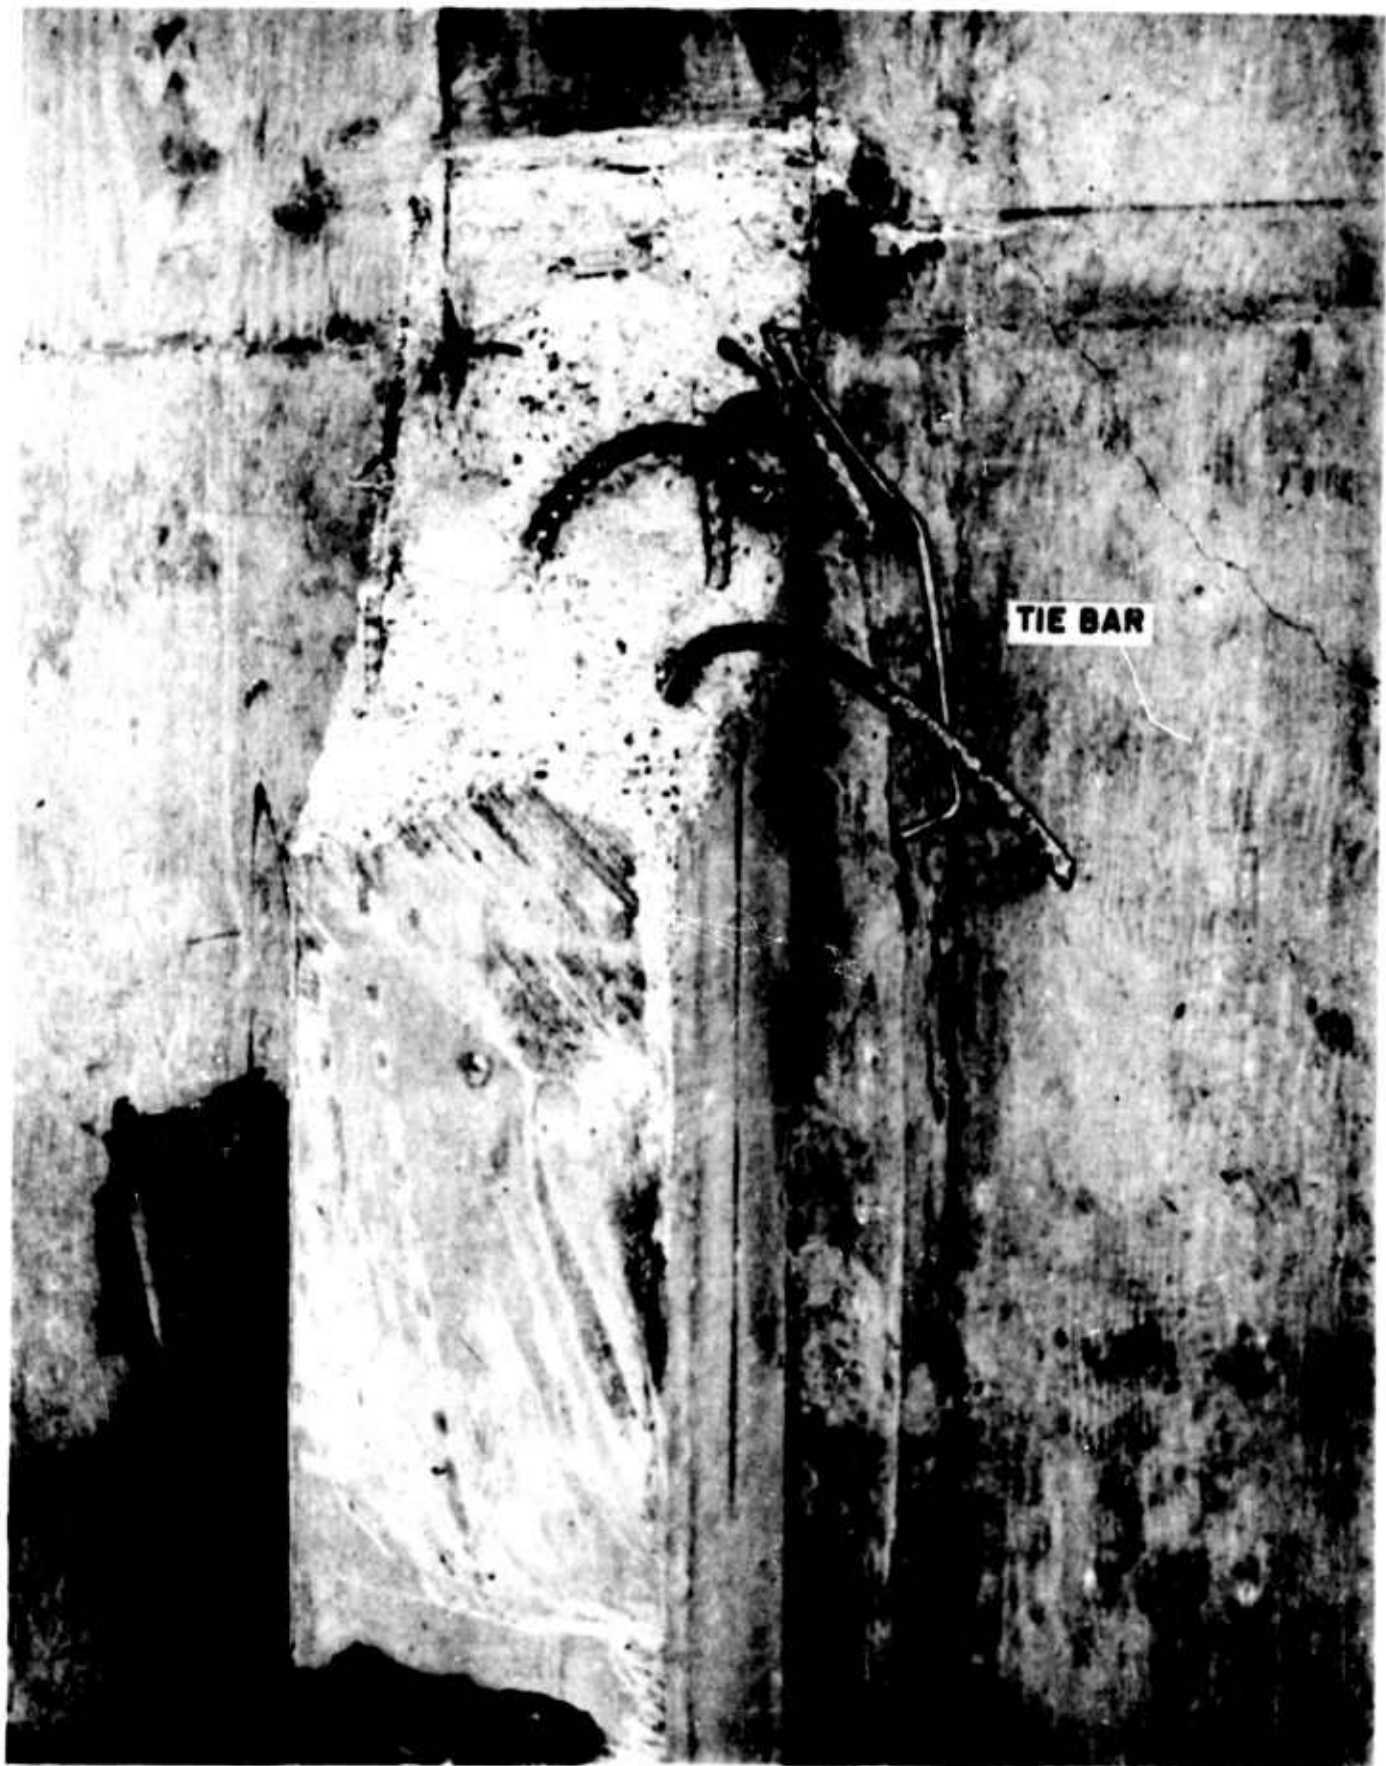
Figure 261. Elmendorf AFB Warehouse
(Closeup of column failure showing tie-rod failure)

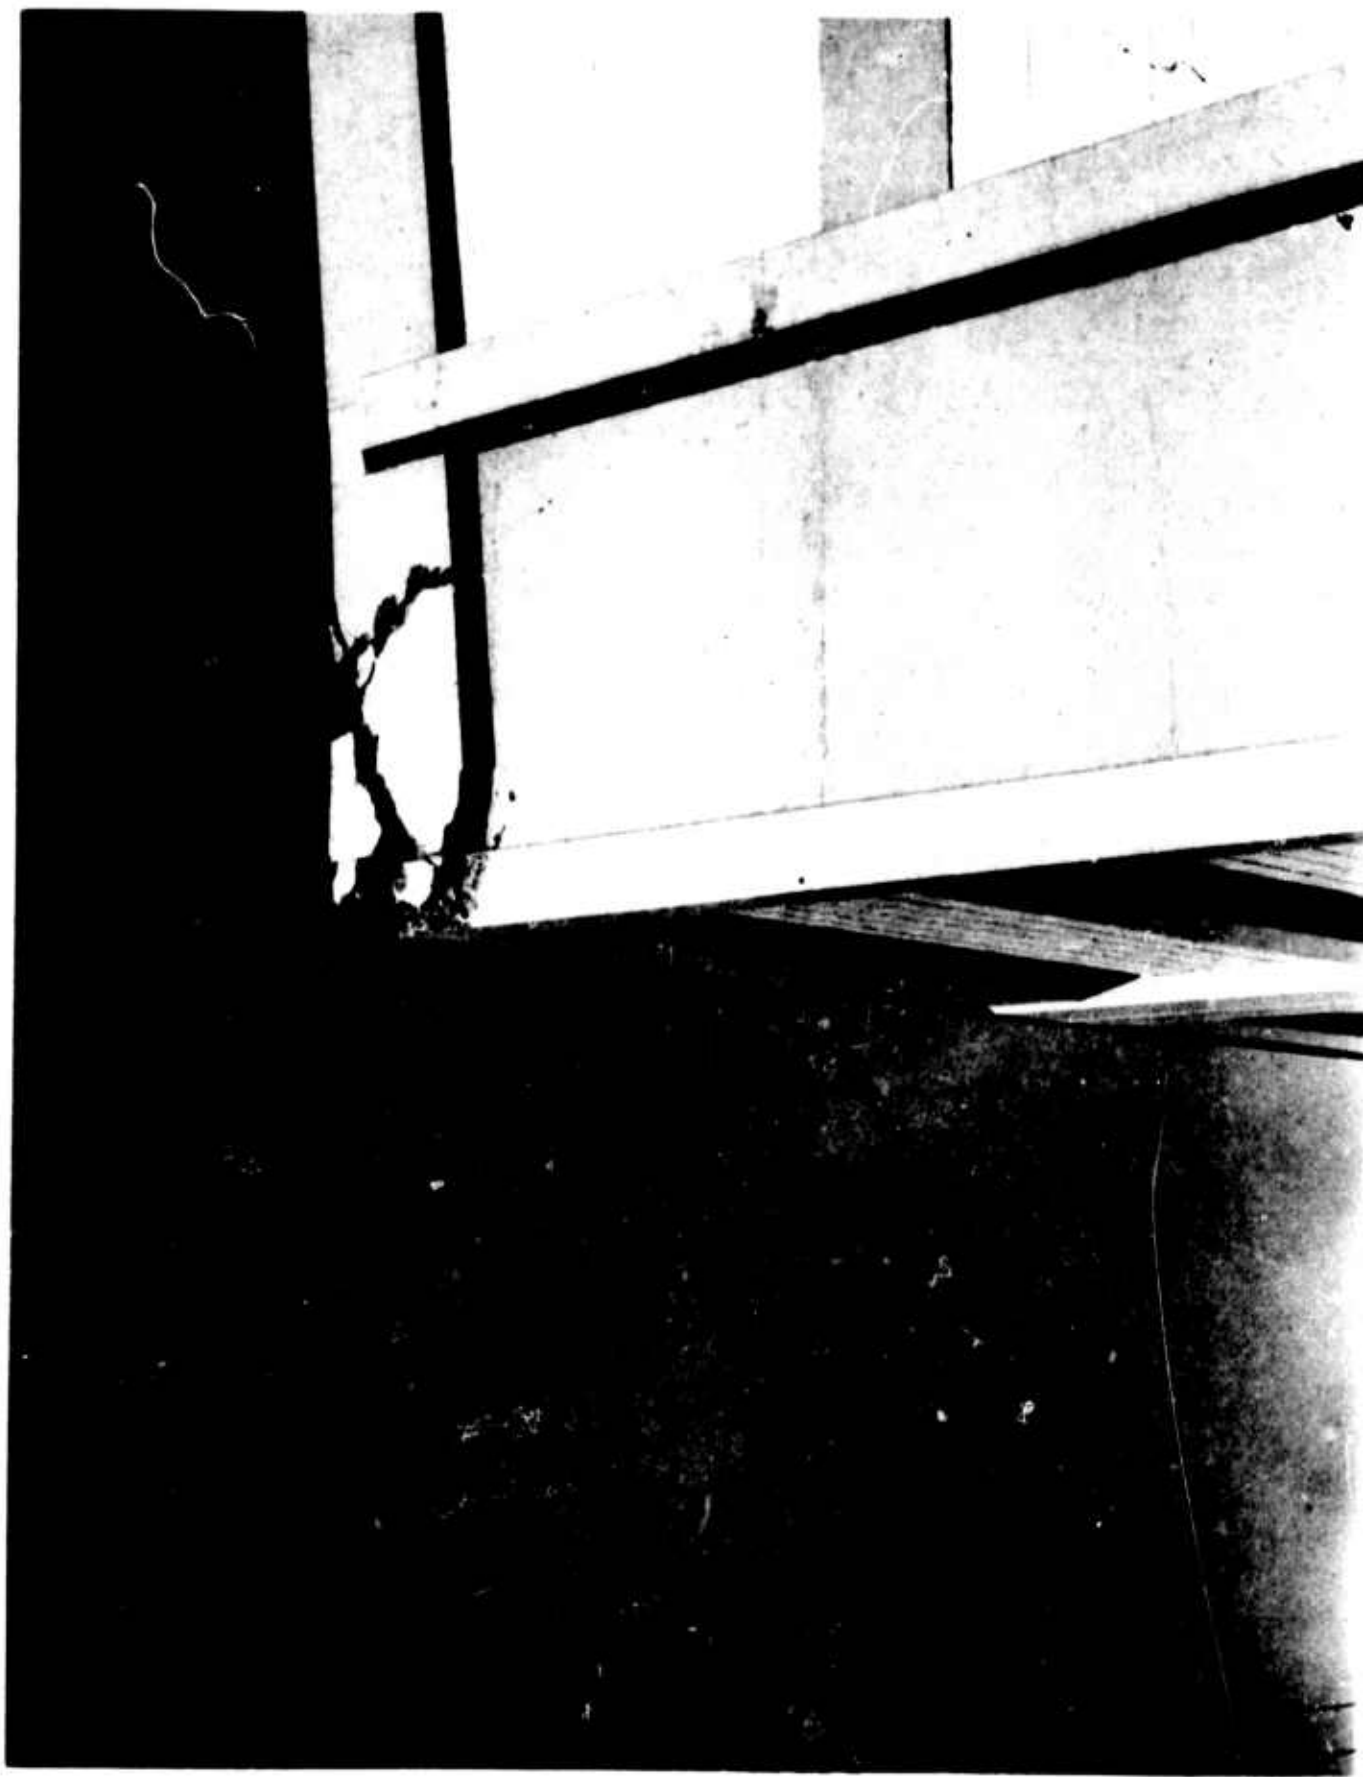
Figure 264. Elmendorf AFB Field House (Closeup of cracks in southwest corner of gymnasium caused by impact of steel rigid frame)

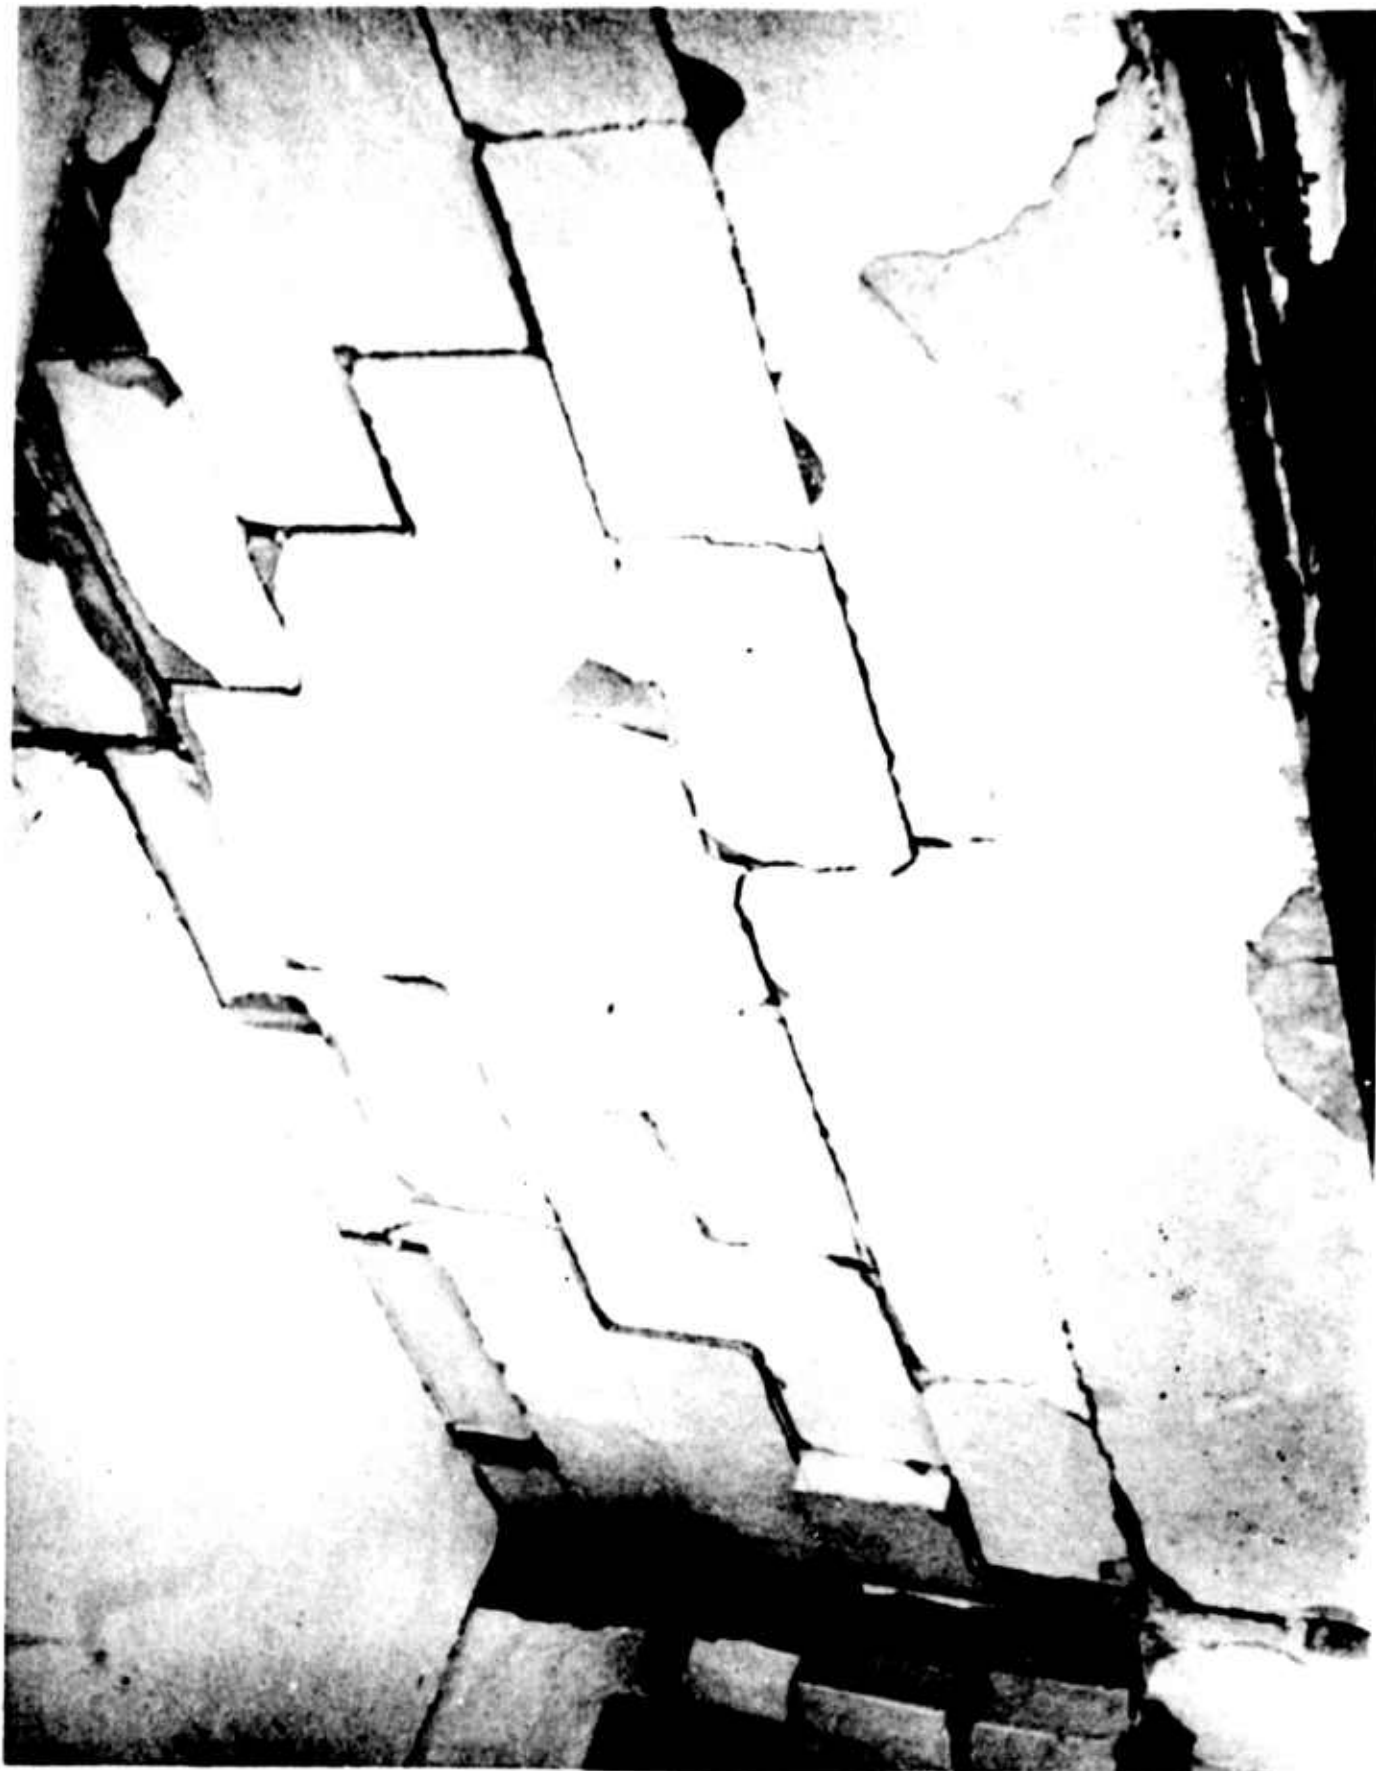
Figure 275. Hillside Apartments (Typical crack pattern of interior masonry-block walls)
